## **CONDITION REPORT**

9 Robert Weir Allan The Return from Fishing

Examined by Brittany Harbidge 11-Aug-2017

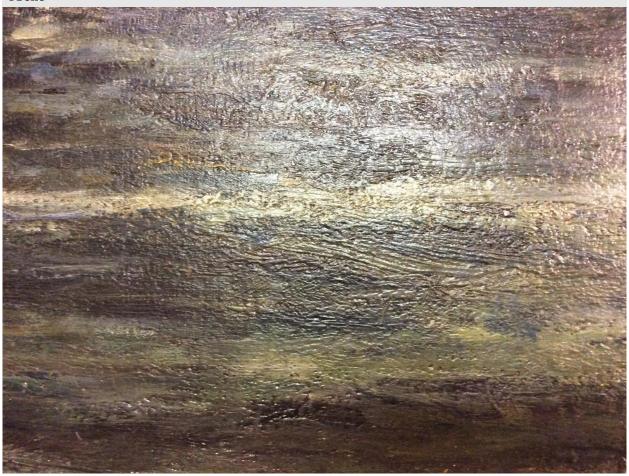
2. Cracking Bottom Left Centre A / Cracks / 11 Aug 2017 / Detail of 1. Overview Front

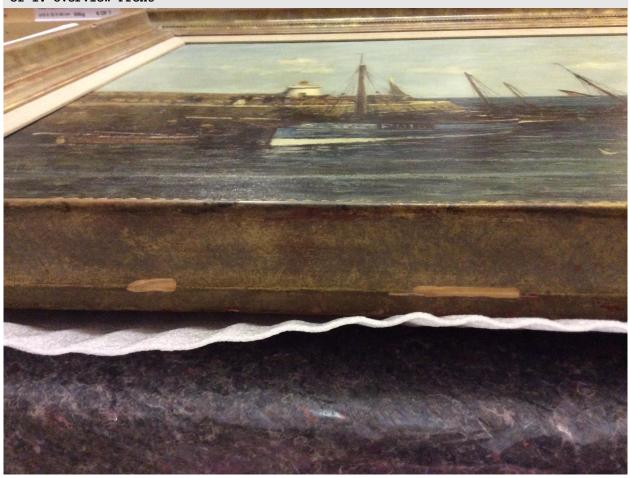
4. Large Chip To Bottom Left Frame Edge B / Knock, corner / 11 Aug 2017 / Detail of 1. Overview Front

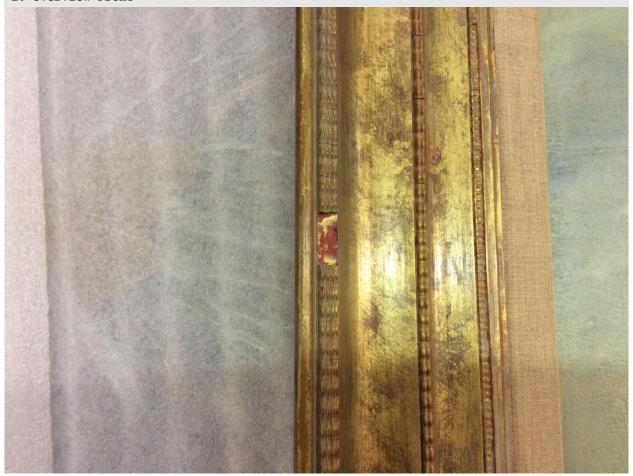
6. Chip To Frame Upper Left Centre D / Knock, corner / 11 Aug 2017 / Detail of

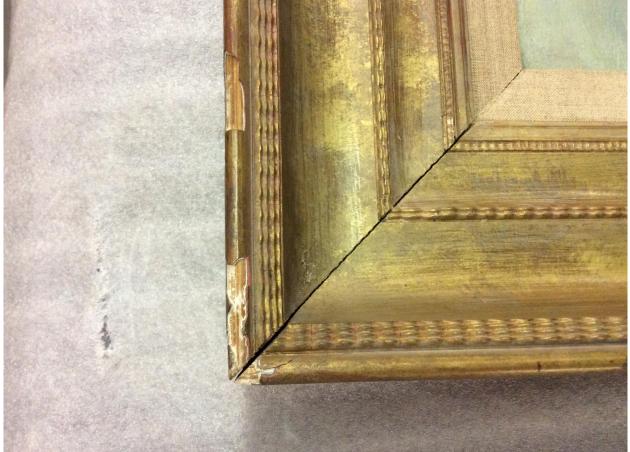
7. Chip To Frame Upper Left Centre  $\,$  E  $\,$  / Knock, corner  $\,$  / 11 Aug 2017  $\,$  / Detail of 1. Overview Front

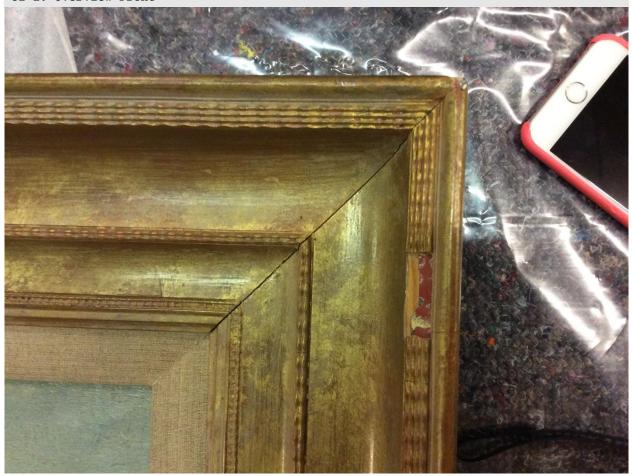
10. Chip To Frame Upper Right Corner  $\, \, {\rm G} \, / \, {\rm Knock} \, , \, {\rm corner} \, / \, 11 \, {\rm Aug} \, \, 2017 \, / \, {\rm Detail} \, \,$  of 1. Overview Front

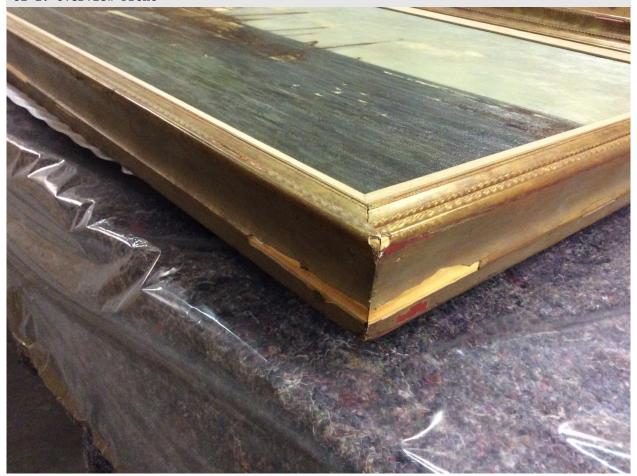
11. Chip To Frame Lower Right Corner  $\,\,$  H  $\,/\,$  Knock, corner  $\,/\,$  11 Aug 2017  $\,/\,$  Detail of 1. Overview Front

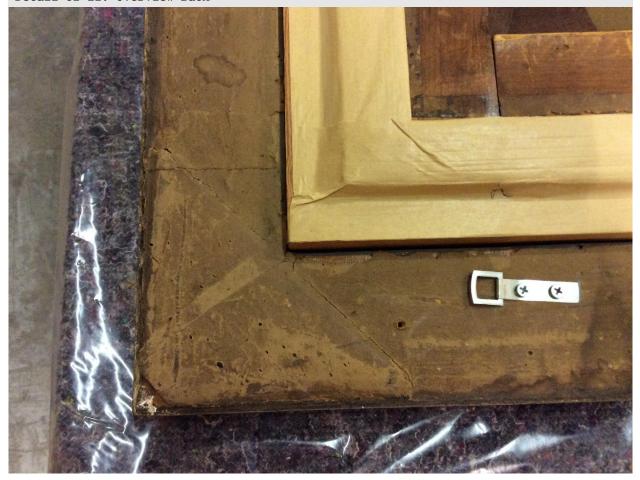
13. Chip To Frame Upper Right Corner Back A / Knock, corner / 11 Aug 2017 / Detail of 12. Overview Back
