## **CONDITION REPORT**

9 Robert Weir Allan The Return from Fishing

Examined by Brittany Harbidge 11-Aug-2017

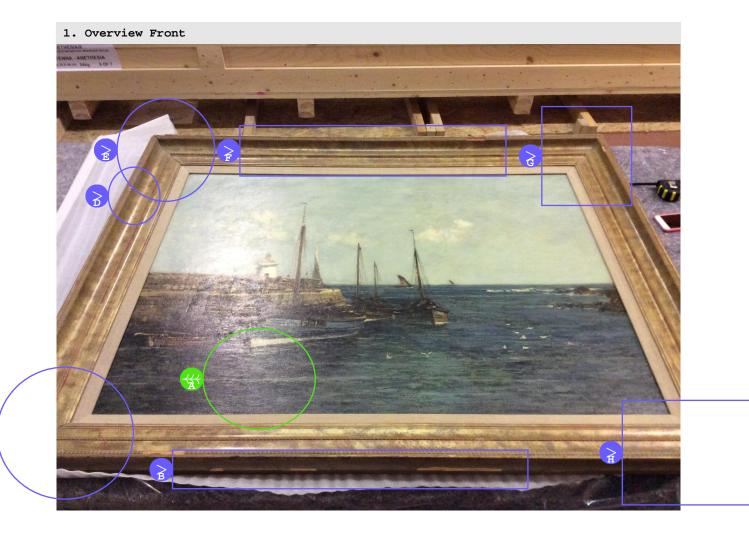
TYPE	DAMAGE LEVEL	DATE	NOTES
A			11 Aug 2017	Minor cracking
В	> Knock, corner		11 Aug 2017	Extensive chips to frame
С	> Knock, corner		11 Aug 2017	Frame chips bottom left corner
D	> Knock, corner		11 Aug 2017	Chip to frame
E	> Knock, corner		11 Aug 2017	
F	> Knock, corner		11 Aug 2017	
G	> Knock, corner		11 Aug 2017	
Н	> Knock, corner		11 Aug 2017

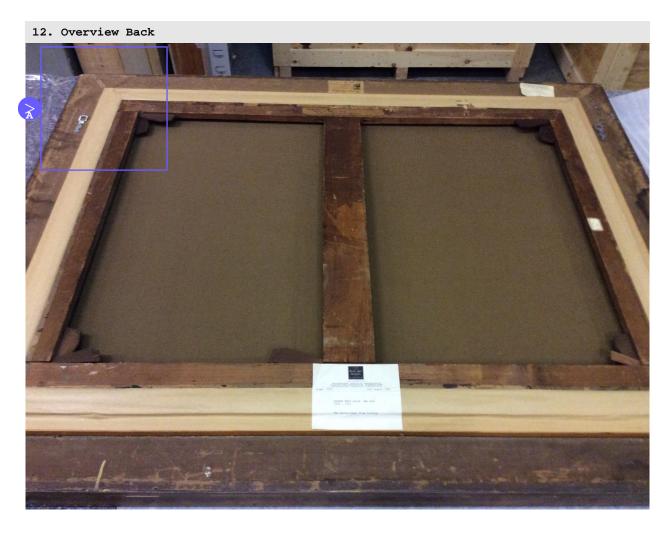
TYPE	DAMAGE LEVEL	DATE	NOTES
Α	Nnock, corner		11 Aug 2017	Frame flaking
